Project: **Purley Leisure Centre**

Client: **Croydon Council**

## Condition Survey of M&E Services

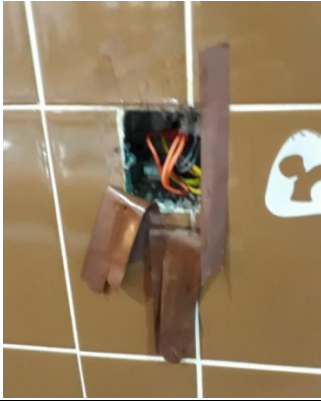
1. Full Electrical Inspection and rectification works – there are various sockets and outlets in the building that are in need of attention.

< Covers missing from socket sin Pool/Wet change side

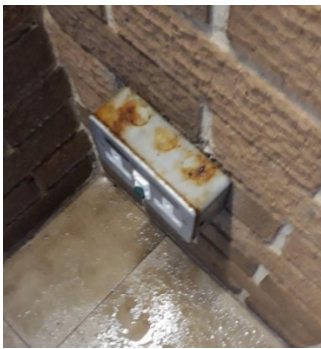
< Condense dropping on outlets not IP rated.

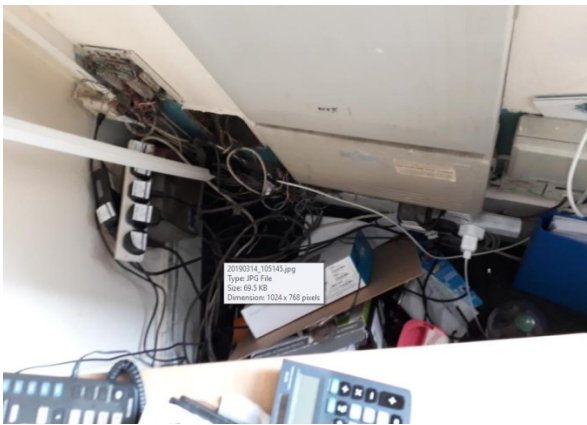
< Use of multiple extension leads

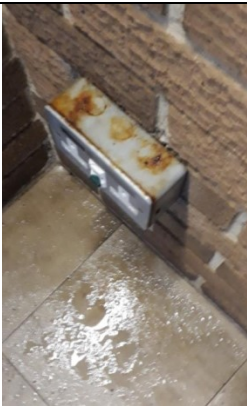
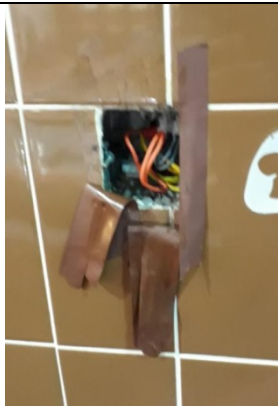
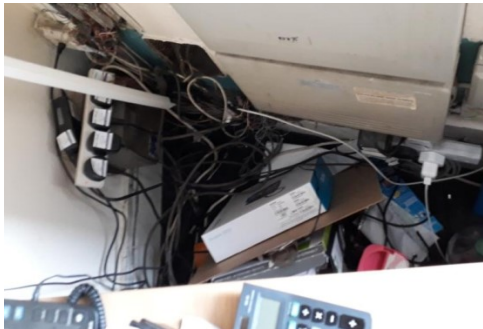
The whole building should be electrically tested and immediate works undertaken to ensure cover plates are secured and/or replaced as appropriate. There are instances throughout the building where covers plates are either not securely, fixed, not IP rate as required and not installed at all.

<p>Condense water dripping on to a non IP rated outlet</p>	<p>No cover plate to live circuits in wet area</p>	<p>Over loading circuits through use of extension cables.</p>
