Project: **Purley Leisure Centre, Croydon** **Asset Register**

Asset Reference: **G.E.109** Inspection Date: **14.03.19**

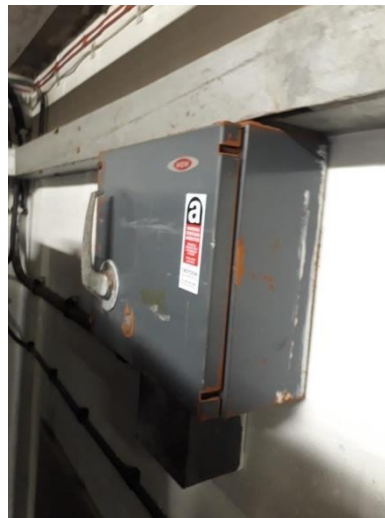
Equipment / Plant Ref: **MEM isolator 100A x 1**

Condition Rating: **Grade C**

Comments: **Medium Corrosion to isolator housing**

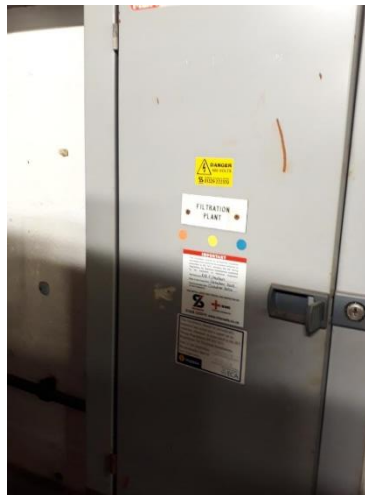
Asset Reference: **G.E.110** Inspection Date: **14.03.19**

Equipment / Plant Ref: **Filtration plant distribution board x 1**

Condition Rating: **Grade B**

Comments: **Medium corrosion to DB housing.
Period inspection expired 03.01.2019
Not lockable.**

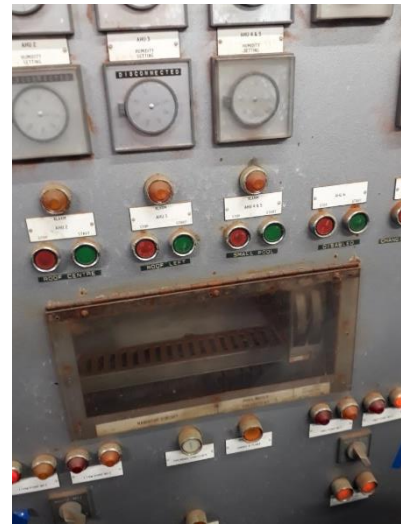
Asset Reference: **G.E.115** Inspection Date: **14.03.19**

Equipment / Plant Ref: **Main TPN ventilation control panel x 1**

Condition Rating: **Grade C**

Heavy Corrosion to control panel housing

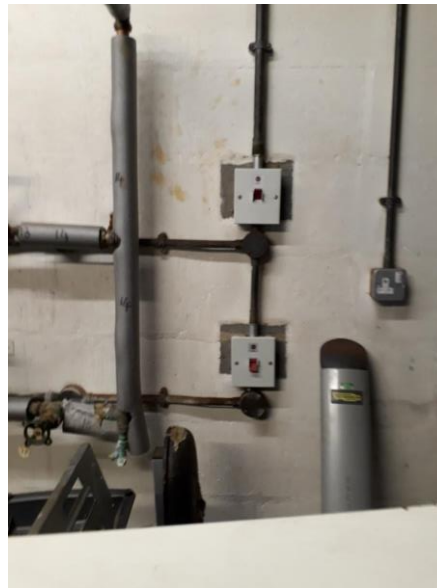
Project: **Purley Leisure Centre, Croydon** **Asset Register**Asset Reference: **G.E.117** Inspection Date: **14.03.19**Location: **Plant Room**Level: **00 - Ground Floor**Equipment / Plant Ref: **MEM isolation to HWS pumps 20A x 2**

Condition Rating: **Grade A**

Priority Grading: **Priority 4** See Section 1.4.2 for detailsEconomic Life: **20** Year From new/installation assuming regular servicing/maintenancePredicated Future Life: **20** YearsComments: **Replaced in recent years.**

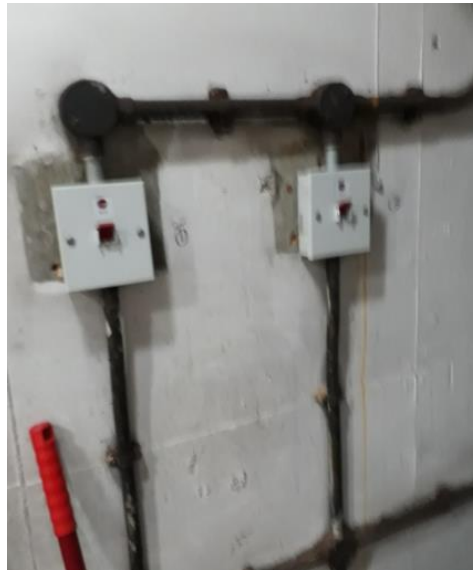
Asset Reference: **G.E.132** Inspection Date: **14.03.19**

Equipment / Plant Ref: **Pump isolator 20 amp x 2**

Condition Rating: **Grade A**

Comments: **Replaced in recent years.**

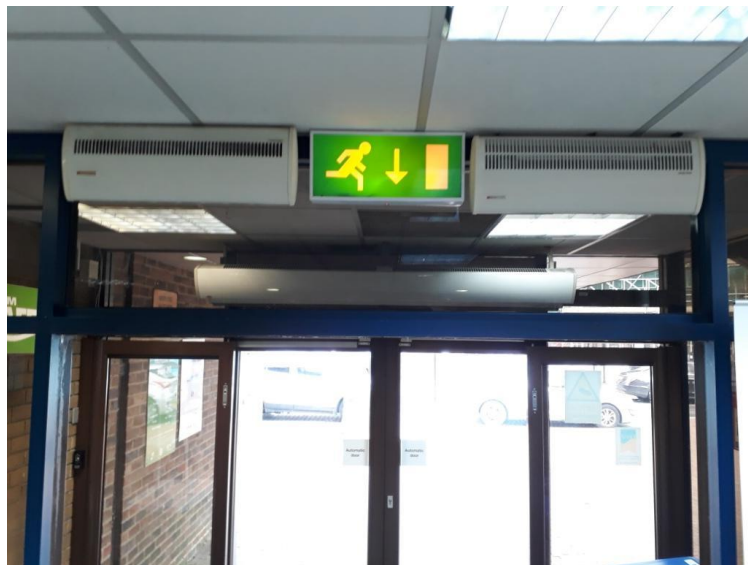
Asset Reference: **G.E.19** Inspection Date: **14.03.19**

Equipment / Plant Ref: **Blow heaters x 2**
 Model Type:
 Quantity: **No.**
 Manufacturer: **Heatstore**
 Serial No: **Not available**

Condition Rating: **Grade B**
 See section 1.4.1 for grading details

Comments: **Condition of the heaters are satisfactory and fair for their age.**

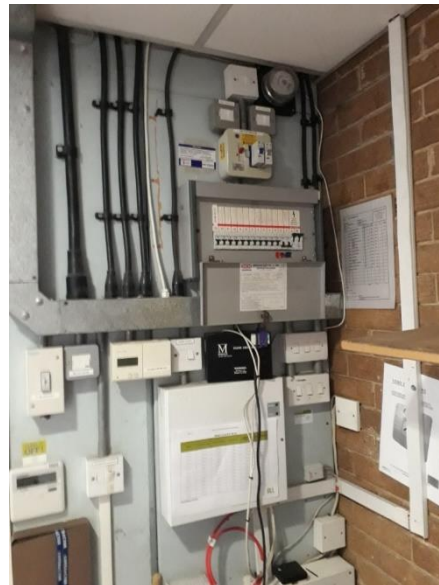
Project: **Purley Leisure Centre, Croydon** **Asset Register**Asset Reference: **G.E.20** Inspection Date: **14.03.19**Location: **Lobby - 02**Level: **00 - Ground Floor**Equipment / Plant Ref: **Elec dist board x 1**Model Type: **Memshield 2**Quantity: **No.**Manufacturer: **MEM**Serial No: **Not available**

Condition Rating: **Grade B**

Priority Grading: **Priority 3** See Section 1.4.2 for detailsEconomic Life: **20** Year From new/installation assuming regular servicing/maintenancePredicated Future Life: **15** YearsComments: **Satisfactory install but bad operational practice. This board is used to switch lighting circuits on and off rather than using local switches. Suggest this is reviewed ASAP.**

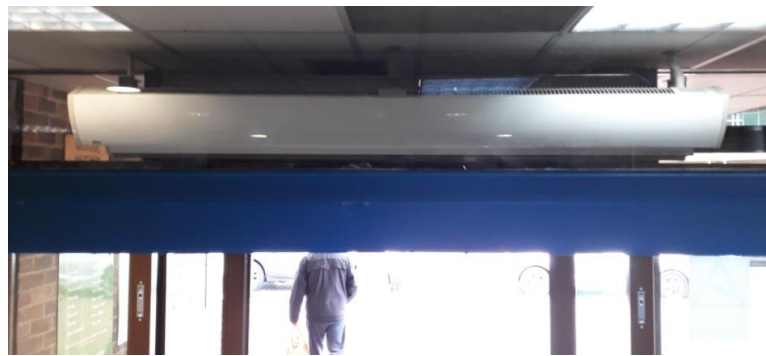
Asset Reference: **G.E.4** Inspection Date: **14.03.19**

Equipment / Plant Ref: **Blow heater x 1**

Condition Rating: **Grade B**

Comments: **Condition of the heater is satisfactory and fair for its age.**

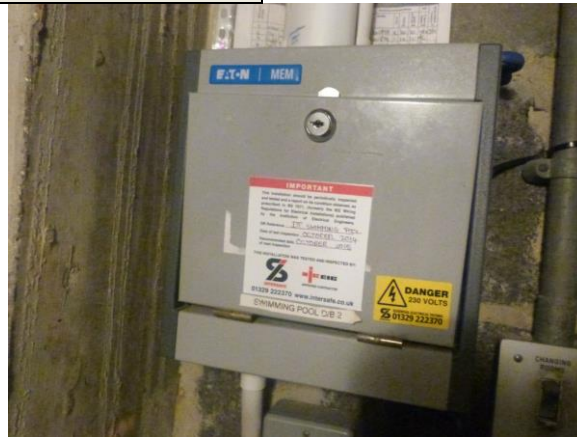
Project: **Purley Leisure Centre, Croydon** **Asset Register**Asset Reference: **1.E.79** Inspection Date: **14.03.19**Location: **Room 42**Level: **01 - First Floor**Equipment / Plant Ref: **Distribution board x 2 DB 1 Changing romm DB2 Swimming Pool**Model Type: **Electrical**Quantity: **No.**Manufacturer: **Db1 MEM DB2 E.T.N**Serial No: **Not available**

Condition Rating: **Grade A**

Priority Grading: **Priority 4** See Section 1.4.2 for detailsEconomic Life: **20** Year From new/installation assuming regular servicing/maintenancePredicated Future Life: **10** YearsComments: **DB's added during pool hall lighting refurb, satisfactory**
