Project:	Purley Leisure Centre, Croydon		Asset Register
Asset Reference:	G.M.1	Inspection Date:	14.03.19
Location:	Plant Room - Room 12		
Level:	00 - Ground Floor		
Equipment / Plant Ref:	Filter tanks (redundant)		
Model Type:	This was previously used when system was on Ozone. Made redundant when UV was installed.		
Quantity:	1	No.	
Manufacturer:	Barr & Wray		
Serial No:	Not available

Project: **Purley Leisure Centre, Croydon** **Asset Register**

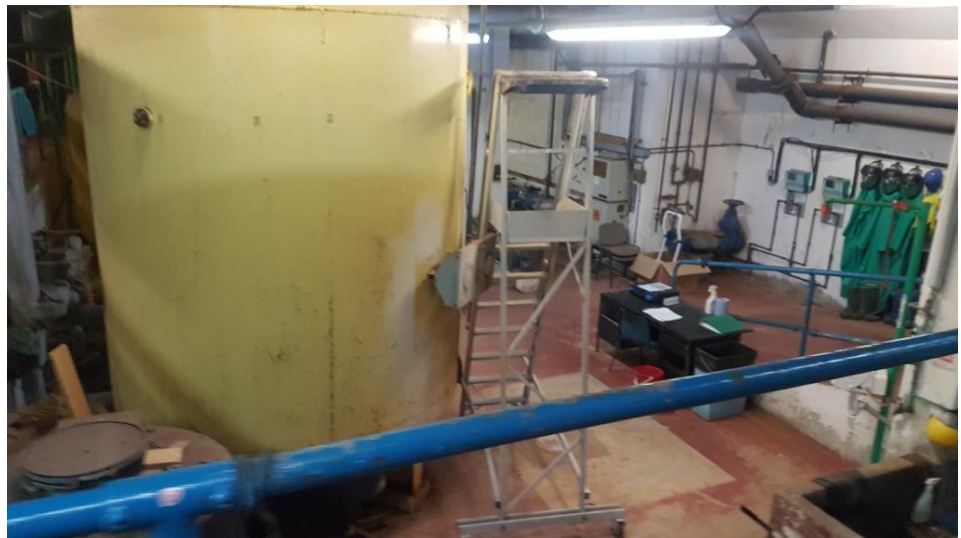
No evident change since last survey in 2015

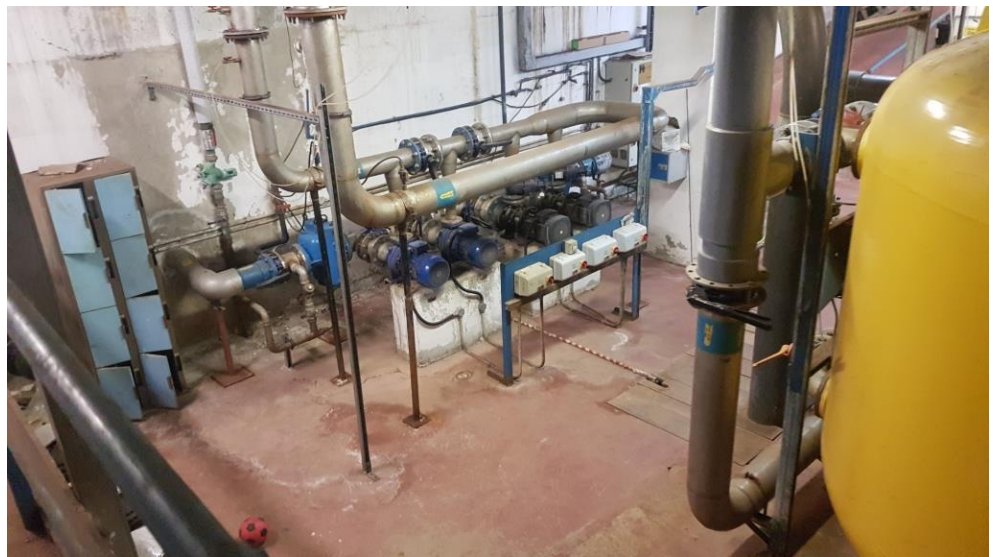
Asset Reference: **G.M.11** Inspection Date: **14.03.19**

Equipment / Plant Ref: **Pool filtration circulating pumps close coupled 7.5kw**

Condition Rating: **Grade C**

Priority Grading: **Priority 3** See Section 1.4.2 for details

Predicated Future Life: **3 to 5** Years

Comments: **No evident change since last survey in 2015**

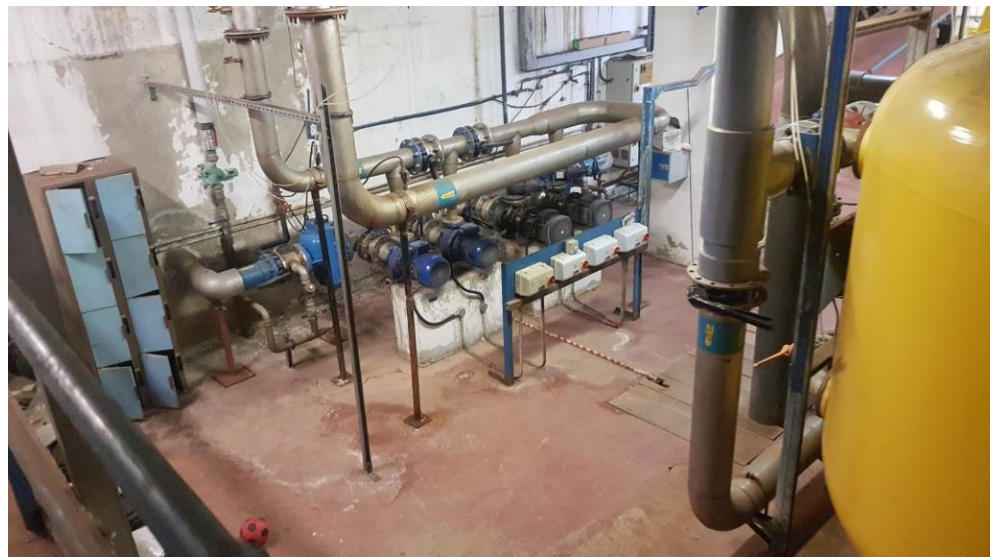
Asset Reference: **G.M.12** Inspection Date: **14.03.19**

Equipment / Plant Ref: **Pool filtration circulating pumps close coupled 7.5kw**

Condition Rating: **Grade C**

Priority Grading: **Priority 3** See Section 1.4.2 for details

Predicated Future Life: **3 to 5** Years

Comments: **No evident change since last survey in 2015**

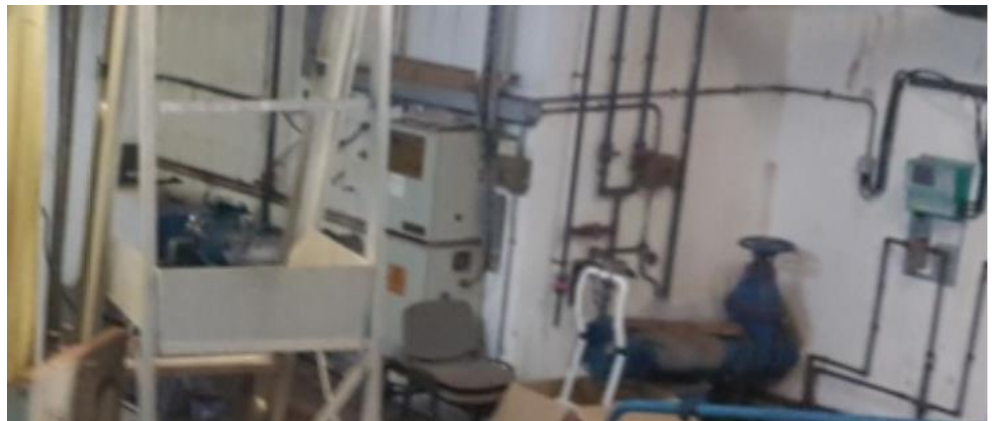
Project:	Purley Leisure Centre, Croydon		Asset Register
Asset Reference:	G.M.15	Inspection Date:	14.03.19
Location:	Plant Room - Room 12		
Level:	00 - Ground Floor		
Equipment / Plant Ref:	Control panel to pumps 1-4 circulating		
Model Type:			
Quantity:	1	No.	
Manufacturer:			
Serial No:	Not available

Condition Rating:	Grade B	See section 1.4.1 for grading details	
Priority Grading:	Priority 4	See Section 1.4.2 for details	
Economic Life:	20	Year	From new/installation assuming regular servicing/maintenance
Predicated Future Life:	2 to 5	Years

No evident change since last survey in 2015

The panel is coming to the end of its economical life. It is operating currently.

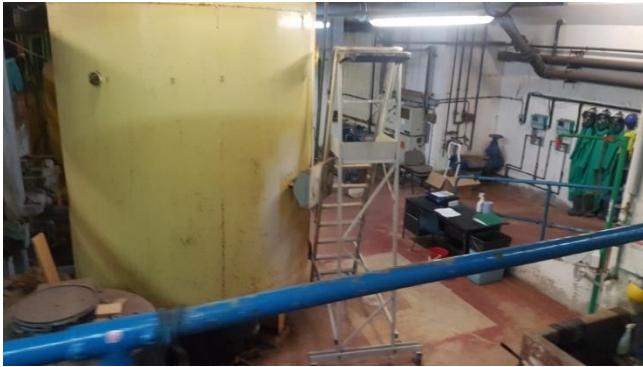
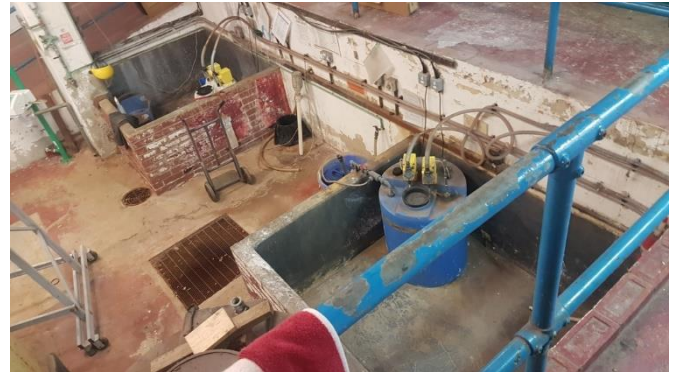
Project:	Purley Leisure Centre, Croydon		Asset Register
Asset Reference:	G.M.18	Inspection Date:	14.03.19
Location:	Plant Room - Room 12		
Level:	00 - Ground Floor		
Equipment / Plant Ref:	Topline water chemistry - Main & small pool control system monitoring panels		
Model Type:			
Quantity:	2	No.	
Manufacturer:	Topline		
Serial No:

Condition Rating:	Grade B	
	See section 1.4.1 for grading details	
Priority Grading:	Priority 3	See Section 1.4.2 for details
Economic Life:	20 Year	From new/installation assuming regular servicing/maintenance
Predicated Future Life:		Years
Comments:	No evident change since last survey in 2015

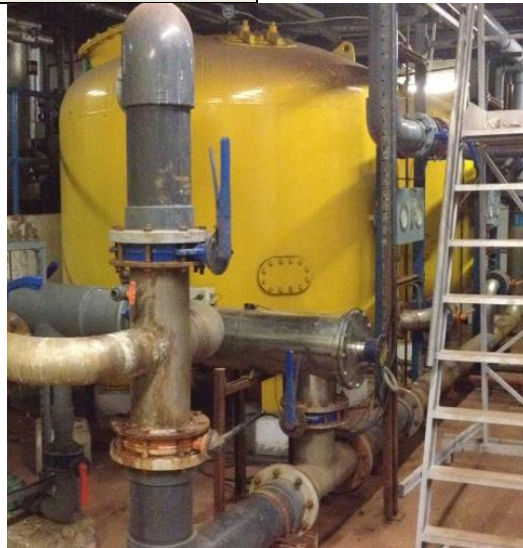
Asset Reference: **G.M.2** Inspection Date: **14.03.19**

Equipment / Plant Ref: **Filter tank A**

Condition Rating: **Grade B**

Priority Grading: **Priority 4** See Section 1.4.2 for details

Predicated Future Life: **5** Years

No evident change since last survey in 2015

**To be serviced annually by Pool Filtration specialist company
Sand to be replaced every 3 to 5 years.**

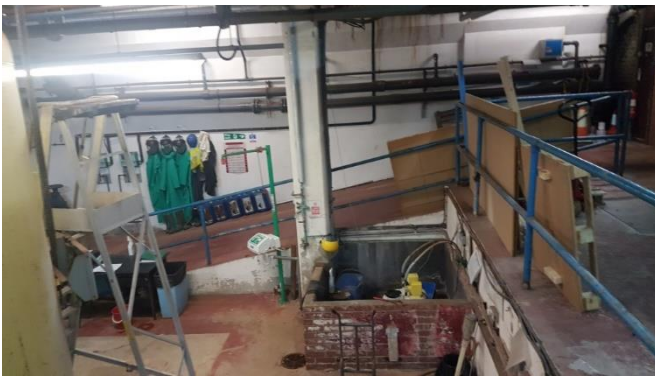
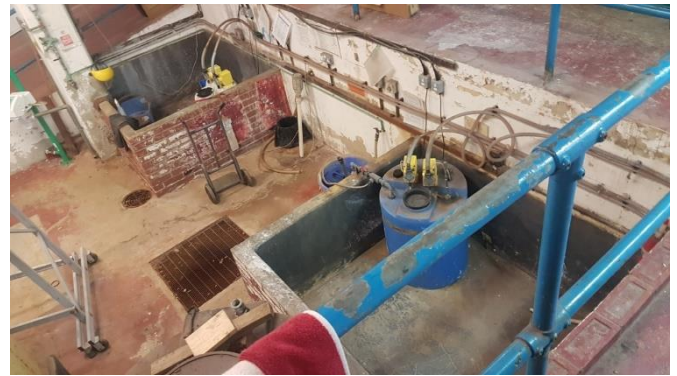
Asset Reference: **G.M.22** Inspection Date: **14.03.19**

Equipment / Plant Ref: **Chemical pool dosing area bund tanks**

Condition Rating: **Grade B**

Priority Grading: **Priority 3** See Section 1.4.2 for details

Predicated Future Life: **2 to 5** Years

Comments: **No evident change since last survey in 2015**

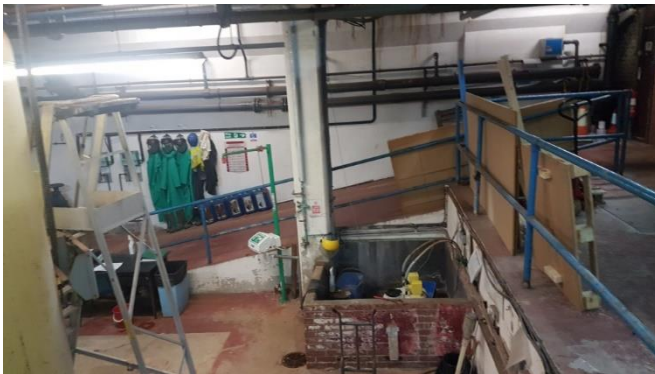
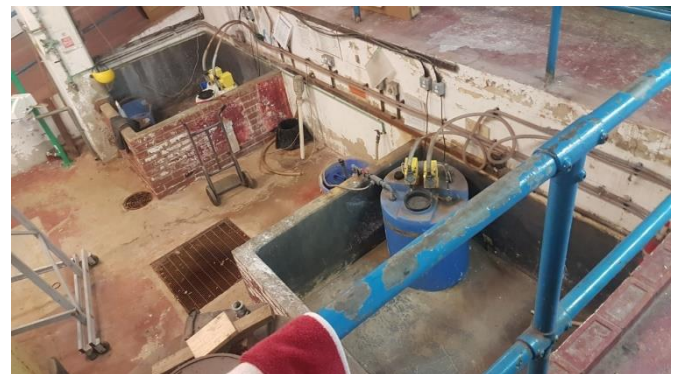
Asset Reference: **G.M.23** Inspection Date: **14.03.19**

Equipment / Plant Ref: **Sodium hypochlorite dosing / meter set**

Condition Rating: **Grade B**

Priority Grading: **Priority 3** See Section 1.4.2 for details

Predicated Future Life: **2 to 5** Years

Comments: **No evident change since last survey in 2015**

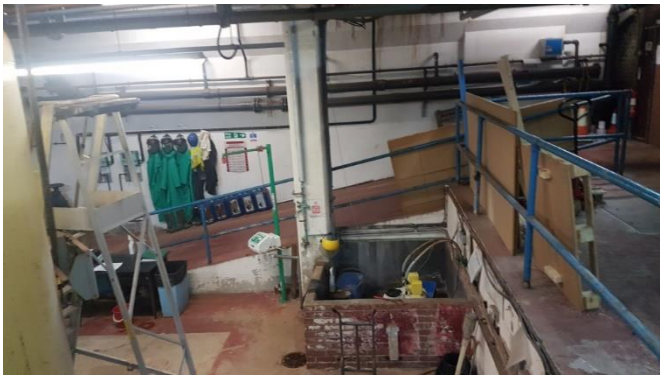
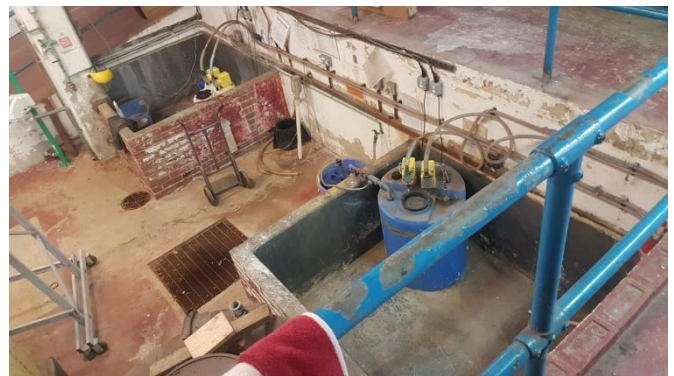
Asset Reference: **G.M.24** Inspection Date: **14.03.19**

Equipment / Plant Ref: **Hypochloric mixture dosing / meter set**

No evident change since last survey in 2015

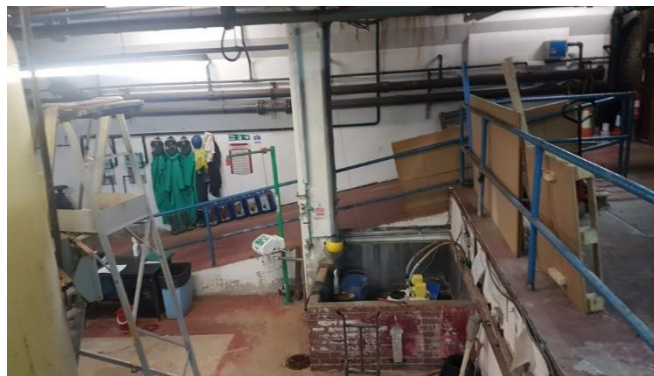
Asset Reference: **G.M.26** Inspection Date: **14.03.19**

Equipment / Plant Ref: **D2 CWS to emergency shower / eye wash**

Condition Rating: **Grade B**

Priority Grading: **Priority 4** *See Section 1.4.2 for details*

Predicated Future Life: **5** Years

**No evident change since last survey in 2015
No test where carried out during the inspection**

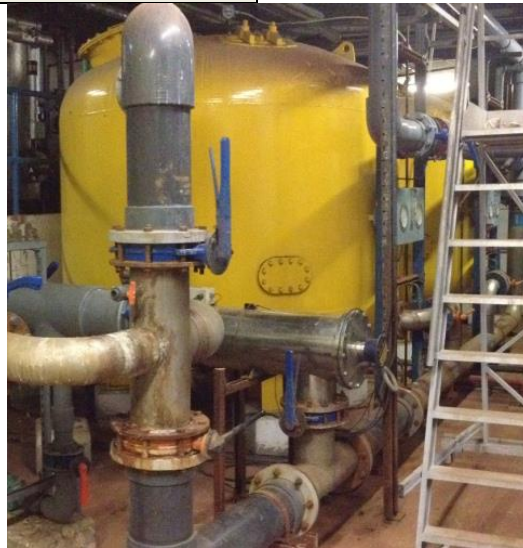
Asset Reference: **G.M.3** Inspection Date: **14.03.19**

Equipment / Plant Ref: **Filter tank B**

Condition Rating: **Grade B**

Priority Grading: **Priority 4** See Section 1.4.2 for details

No evident change since last survey in 2015

**To be serviced annually by Pool Filtration specialist company.
Sand to be replaced every 3 to 5 years.**

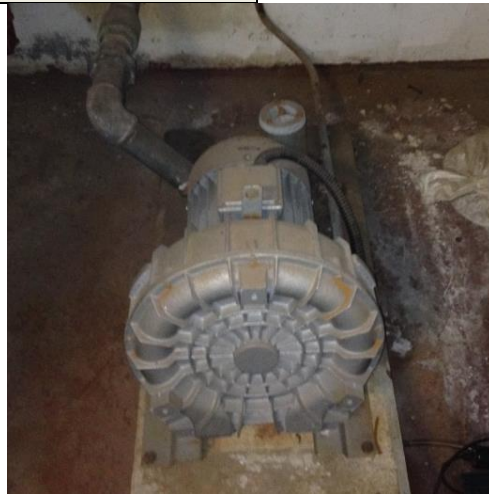
Asset Reference: **G.M.48** Inspection Date: **14.03.19**

Equipment / Plant Ref: **Air blower unit and close coupled motor drive**

Condition Rating: **Grade B**

Priority Grading: **Priority 4** See Section 1.4.2 for details

Predicated Future Life: **5** Years

No evident change since last survey in 2015

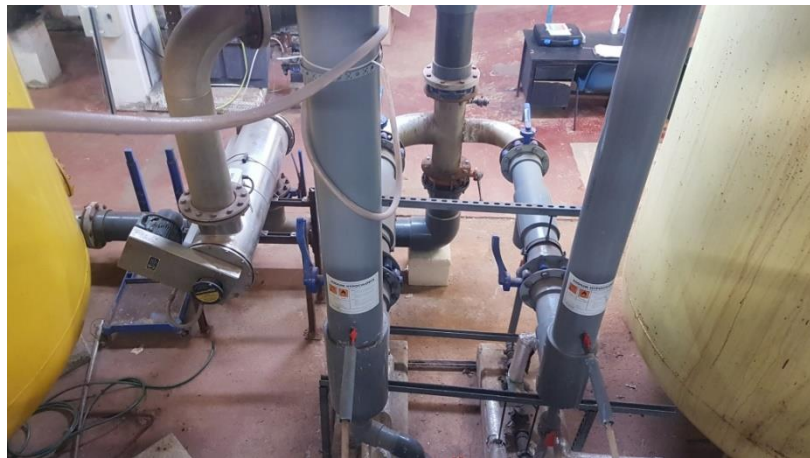
Asset Reference: **G.M.6** Inspection Date: **14.03.19**

Equipment / Plant Ref: **Hanova ultra violet water treatment unit**

Condition Rating: **Grade B**

Priority Grading: **Priority 4** See Section 1.4.2 for details

Predicated Future Life: **5** Years

Comments: **No evident change since last survey in 2015**
To be serviced annually by Pool Filtration specialist company
Run time hours indicated at time of inspection - 96,423 hrs (suggest counter has not been reset after replacement).

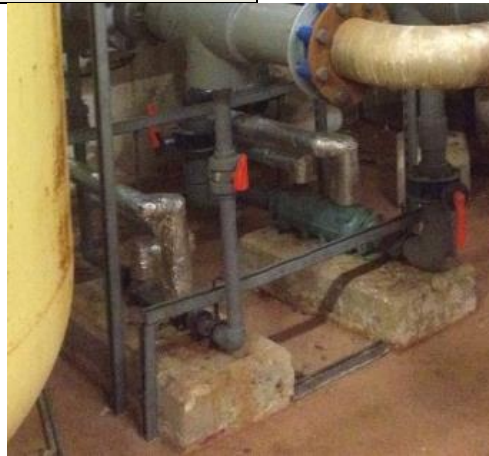
Asset Reference: **G.M.7** Inspection Date: **14.03.19**

Equipment / Plant Ref: **Heat exchange unit main pool**

Condition Rating: **Grade B**

Priority Grading: **Priority 3** See Section 1.4.2 for details

Predicated Future Life: **3 ot 5** Years

No evident change since last survey in 2015

No signs of leaks from the PHX's. They are not insulated.

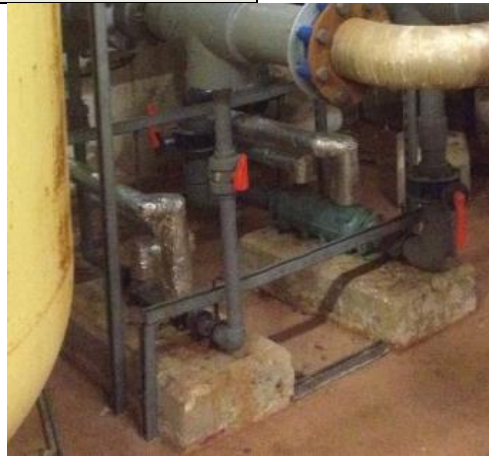
Asset Reference: **G.M.8** Inspection Date: **14.03.19**

Equipment / Plant Ref: **Heat exchange unit learner pool**

Condition Rating: **Grade B**

Priority Grading: **Priority 3** See Section 1.4.2 for details

Predicated Future Life: **3 to 5** Years

No evident change since last survey in 2015

No signs of leaks from the PHX's. They are not insulated.
